Influence of Material Composition on Corrosion of Modular Hip Prostheses

Norman Munroe, Vishal Musaramthota, Jose Gonzalez and Kinzy Jones, Florida International University

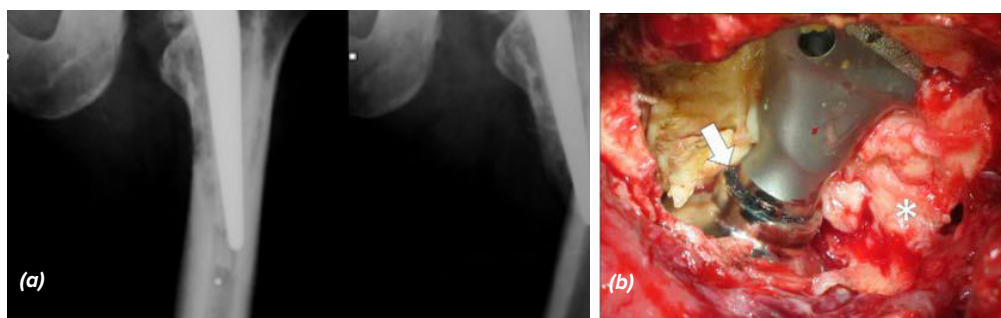
Figure 1: (a) X-Ray image illustrating femoral stress shielding (dark shade of the bone to the right is indicative of reduced bone density) [10]; (b) Intraoperative photograph illustrating corrosion at the head neck interface resulting in adverse local inflammation [11].

Implant loosening, commonly referred to as aseptic loosening, occurs as a result of stress shielding as well as osteolysis. In the case of stress shielding, the introduction of the femoral implant shifts the load once borne by the bone onto the implant of higher elastic modulus, thereby removing the mechanical stimulus that is required for bone formation. The result is bone resorption and reduced bone density in the areas surrounding the implant as shown in Figure 1 (a), ultimately leading to a loss of implant fixation. On the other hand, osteolysis is a complex physiological process initiated by metal ion release and/or wear particles from the implants head-stem interface that affect the immune system and bone metabolism [8, 9], causing pseudotumors, adverse immune reactions, and infections that lower the pH of nearby periprosthetic tissues as shown in Figure 1(b).

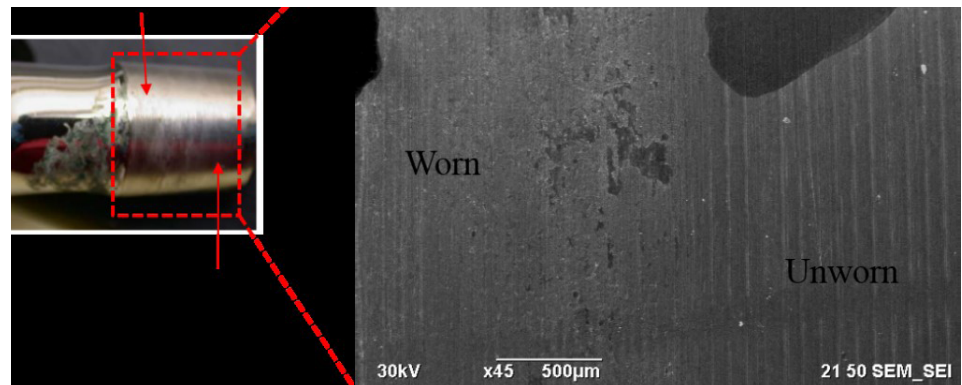
Figure 2. Taper surface of explanted prosthesis on left and the SEM micrograph of the taper showing worn and unworn mating surfaces

surface motion occurred were compared with that of no relative motion. A comparison of corrosion severity was conducted between prostheses with high carbon Co-Cr-Mo head with low carbon Co-Cr-Mo stems (Co/Co) and those composed of high carbon Co-Cr-Mo heads with Ti-6Al-4V stems referred to as mixed alloy (Ti/Co). Figure 2 shows a photomicrograph comparing worn and unworn surfaces of a trunnion taper interface. Unworn surfaces can nearly always be found in the distal taper area of femoral heads. However, unworn regions are rare in trunnion tapers unless the taper extended beyond the bore of the femoral head. In cases where the entire trunnion taper was in contact, the asymmetrical nature of fretting wear along the circumference of the taper can be used as a reference point.

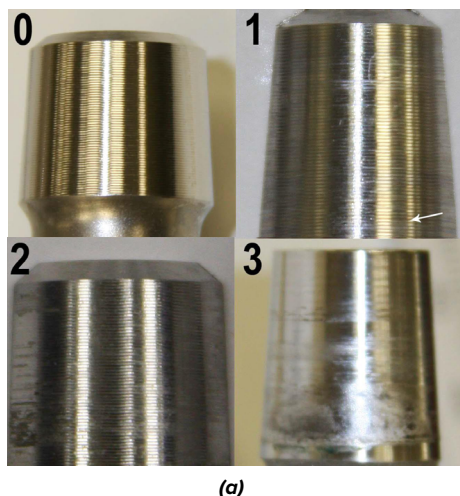
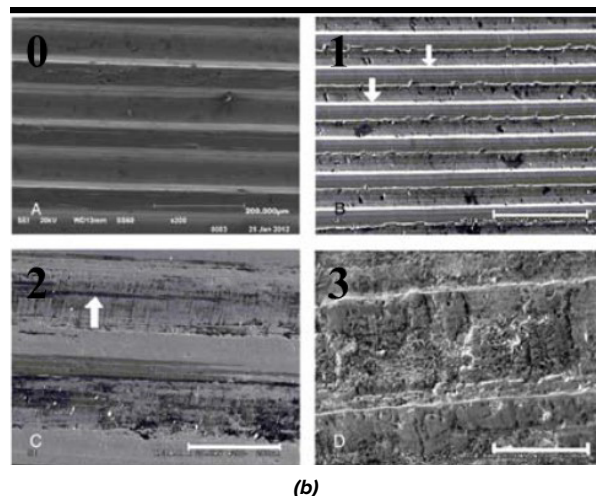
Figure 3: (a) Tapers with various degrees of corrosion damage as classified by Goldberg: (0) None, (1) Mild, (2) Moderate and (3) Severe. (b) SEM micrographs of fretting corrosion as per Goldberg criteria.

Discoloration in the form of a tarnish film was considered to be a mild form of corrosion as shown in Figure 3a. Dullness can either be the result of a proteinaceous film or etching of the fine microstructure of the taper components. Homogenous dullness that covered the entire surface area was attributed to surface finish particularly with titanium components.

Ascertaining the difference between fretting and general corrosion can be difficult, particularly when a surface is extensively corroded. Fretting corrosion refers to corrosion damage under load and in presence of repeated relative surface motion, whereas general corrosion is more or less uniform corrosion without appreciable localization or pits. In some cases, damage is severe enough to warrant assigning the same score to both fretting and corrosion. Fretting damage tends to manifest itself as single, off-angle, long narrow scratches over many machine lines. Fretting damage caused by impaction or disengagement during retrieval were disregarded. Utilizing Goldberg criteria, the explanted prostheses samples were scored and reported in Figure 4.

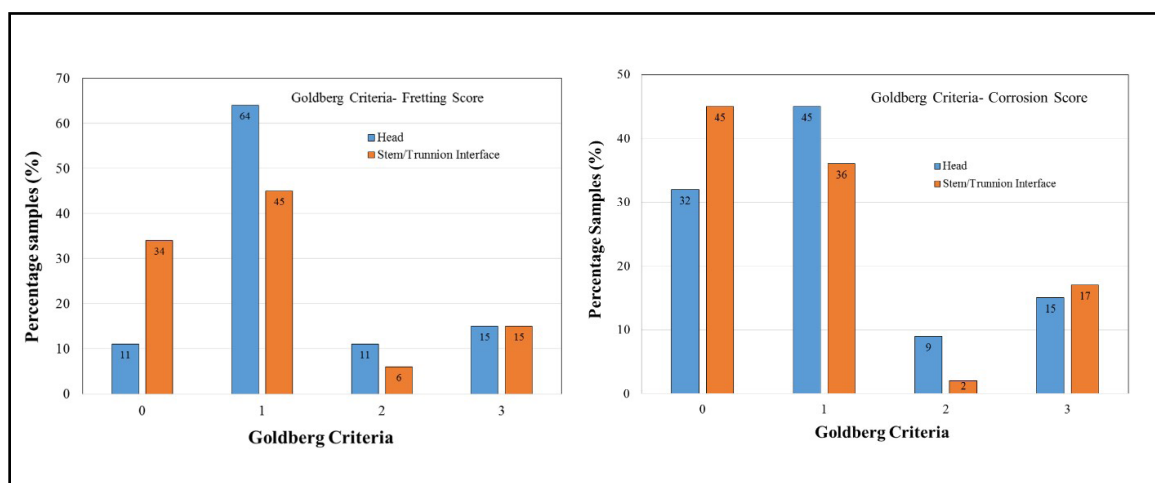
Figure 4: Corrosion severity of explanted prosthesis as per Goldberg's criteria: (0) None, (1) Mild, (2) Moderate and (3) Severe; (a) Fretting scores (b) Corrosion scores

Of the 47 randomly selected head and stem/trunnion explanted prostheses, approximately 15% exhibited severe (score 3) general corrosion as well as fretting corrosion. There was no significant difference in the degree of corrosion severity between the head and stem/trunnion interface. However, of the 36 head and stem/trunnion Co-Cr-Mo samples, 11% exhibited severe

corrosion whereas of 10 head and stem/trunnion Ti-6Al-4V samples, 40% exhibited severe corrosion.

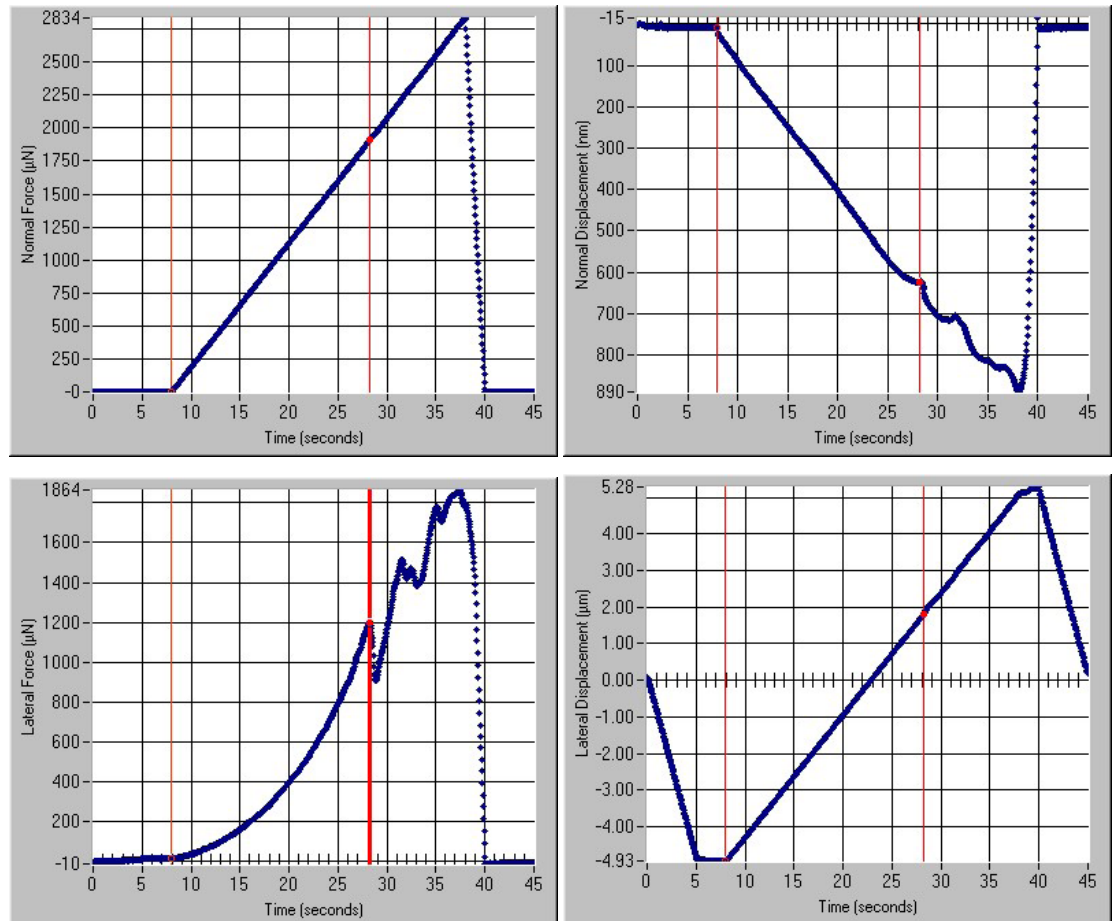
Figure 1. Nanoscratch test data obtained on an organic thin film on Si substrate specimen.

interface. The failure events of the film are normally symbolized by a combination of sudden changes in the lateral force, normal displacement, and/or normal force data. The critical load is defined as the normal force applied to the scratch probe at the time when interfacial failure is detected and can be determined by analyzing the

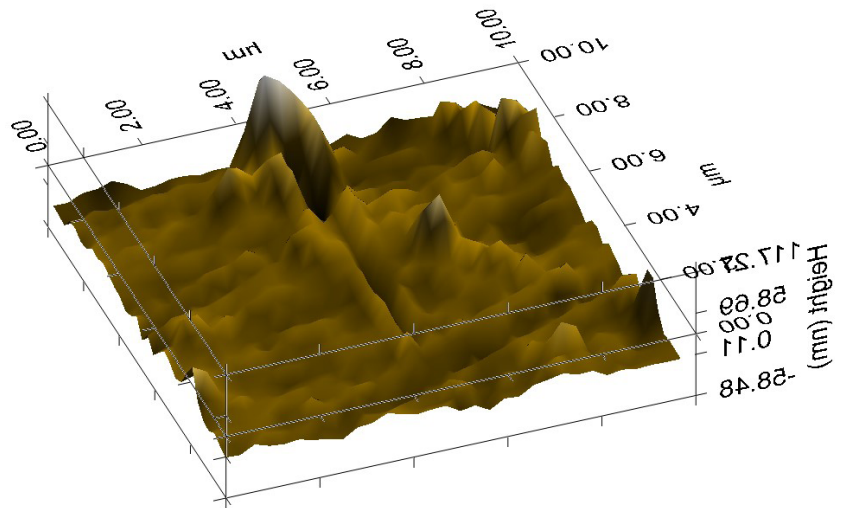
Figure 2. 3D plot of a nanoscratch conducted on a polymer film on metal substrate for interfacial adhesion evaluation imaged through in-situ SPM imaging.
